Manhole Inspection Summary

Manhole # S07YY1013MH

Insp Date: **9/13/06 8:17 AM**

Location Address: **3000 ROCKWOOD AVE**

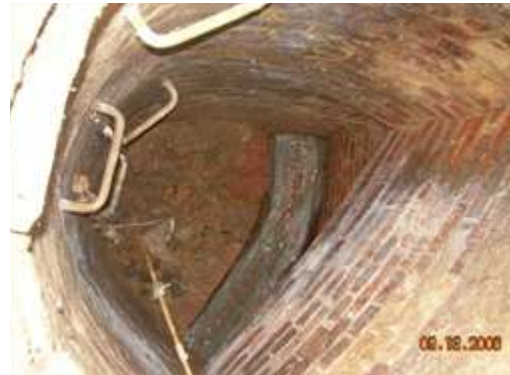
Top View

☐ Parged ☒ **Debris** (not Condition related)

☒ **Evidence Of Surcharge** Depth: **3** (ft.) ☐ Active Surcharge Present

Evidence of surcharge - Bench debris.

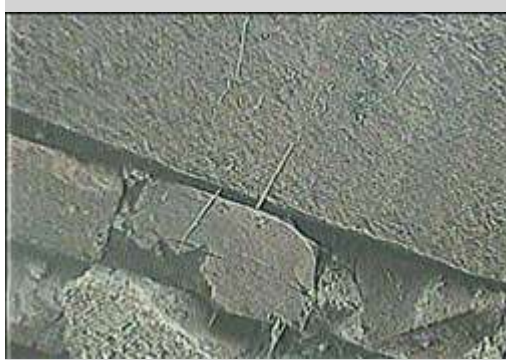
Defect

Condition: ☐ Sound ☐ Cracked ☒ **Leaks**

Condition: ☐ Sound ☐ Cracked ☐ Root Intrusion ☒ **Loose Brick** ☒ **Deteriorated**

Infiltration: ☐ None ☒ **Joint** ☐ Cracks ☒ **Mortar** ☐ Roots ☐ Wall

Frame leaks. Adjustment deterioration, loose brick, and infiltration.
